Part B: Monitoring Program Implementation and Report

9 Monitoring Program – Quarter 1

Summary of sampling event

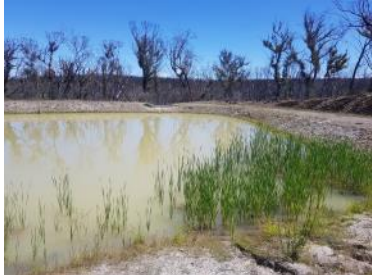
Basins	
Basin 5 (at 50m range)

<ul style="list-style-type: none"> • Basin full • Note scour near entrance – discussed further

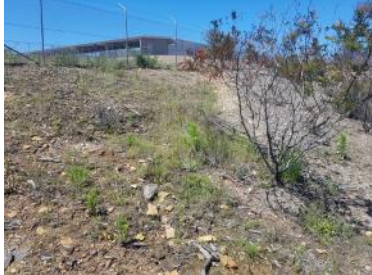
<ul style="list-style-type: none"> • Scour over batter at entrance to basin enclosure • Water directed by surface water swale to entrance track to basin • Scour leads down access track to spread at bench and then down batter at basin <p>Suggest a formalise drain will be required in this location to arrest further scour – rock over fabric</p>

5.	Basin 4 (car park)	<p>Inlets and outlet areas are stable. No issues or required action is evident.</p>
6.	Basin 5 (50m)	<p>Scour is evident over batter at entrance to basin enclosure.</p> <p>Water is directed by surface water swale towards entrance track to basin.</p> <p>Scour leads down access track to spread at bench and then down batter at basin leading to scour.</p> <p>Suggest a formalise drain will be required in this location to arrest further scour – rock over fabric</p>

2. Investigate works to provide an additional inlet at the access track to Basin 5.
3. Include clearing of sediment from drainage and culverts within the road network to the 50m and 500m ranges.
4. Investigate works to re shape top of stop butt mounds at the 50 and 500m ranges
5. Investigate works to improve stabilisation/vegetation rear of the stop butt mounds at the 50 and 500m ranges and associated drainage
6. Investigate works to improve check measures (as required) at the swale drains at the Eastern side of the 500m range and South Eastern corner of the 500m range.
7. Investigate works to maintain / improve drainage outlet at the southern corner at rear of 50m range.
8. Confirm treatment of the 50m intermediate mound at 500m range per recommendations from 2020 Annual Monitoring Report.

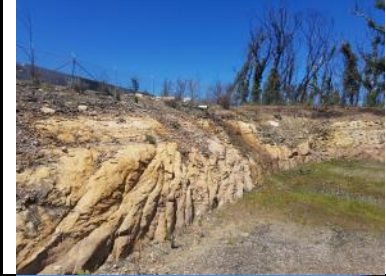
<ul style="list-style-type: none"> • Water flowing from water treatment process / pits exiting low flow pipe to basin

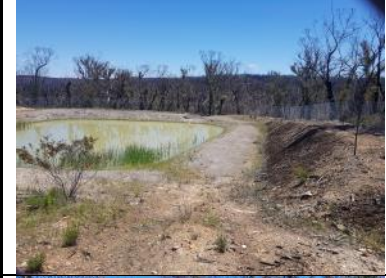
<ul style="list-style-type: none"> • Spillway and outlet area stable

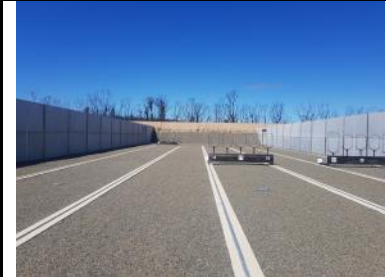
<ul style="list-style-type: none"> • Grave surfaces weed free

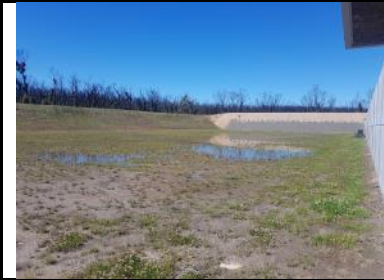
<p>Range/Bay 1</p> <ul style="list-style-type: none"> • Water pooling in central area • Not riling over batter of butt to South western side

Item	Location	Observation and Comment
1.	Range 1 – 50m range	Localised pooling is occurring in the middle of the range. This pooling is impacting establishment of surface cover. Erosion is not evident over the surface
2.	Various – 500m range	Localised pooling is occurring in several locations within the 500m range. This pooling is impacting establishment of surface cover. Erosion is not evident over the surface

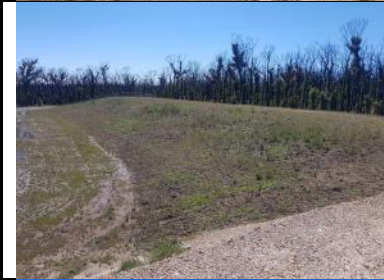
<p>Mound SE of Range/Bay1</p> <ul style="list-style-type: none"> • Vegetation patchy – surface generally stable • Some sediment localised loss

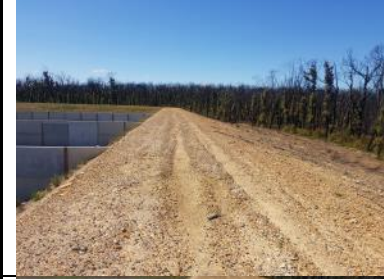
<p>Top of Stop butt at 500m</p> <ul style="list-style-type: none"> • Some riling at front of batter • Occurs where water is pooling on top of butt formation and overflows over face <p>Rework of top of the mound formation will be required to prevent surface water passing over the batters of the stop butt.</p>

Item	Location	Observation and Comment
1.	Stop butt – 500m range	Some riling at front of batter occurring where water is pooling on top of butt formation and overflows over face Rework of top of the mound formation will be required to prevent surface water passing over the batters of the stop butt.

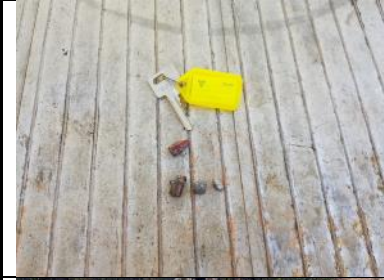
<ul style="list-style-type: none"> • Bullet fragments within stop butt area above bullet catchers

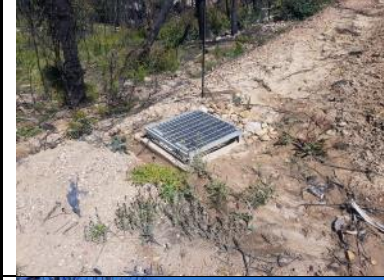
<ul style="list-style-type: none"> • Pit at South East corner of 50m stop butt • Pit is full of sediment and being bypassed <p>Modification of this outlet area may be required.</p>

2.	Pit at South East corner of 50m stop butt	Pit is full of sediment and being bypassed Modification of this outlet area may be required depending on existing stormwater arrangement E.g. additional control to prevent pit becoming blocked or otherwise replace with a stable surface level outlet and spreader.

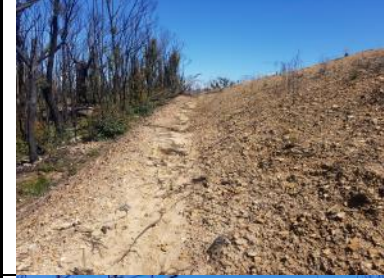
<ul style="list-style-type: none"> • Drain to stormwater pit bare • Minor sediment loss evident <p>Further stabilization of the back of the mound will be required to reduce the sediment load to the drainage outlets.</p>

3.	Drain at rear of 50m stop butt	The Drainage swale leading to the SE stormwater pit is bare with sediment loss evident Further stabilization of the back of the mound will be required to reduce the sediment load to the drainage outlets.

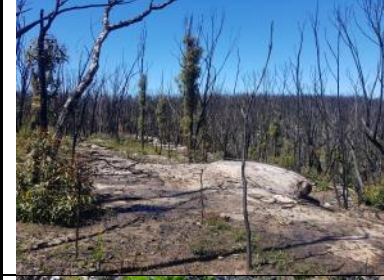
<ul style="list-style-type: none"> • Bushland external to 50m range • Natural regeneration commencing – limited ground covers

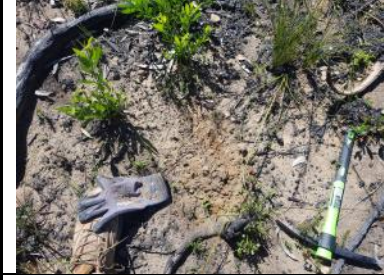
<ul style="list-style-type: none"> • Very little cover of surface • Root material beginning to be evident in surface soils/topsoils
<p>Engineering controls: Lime treatment Process</p> <ul style="list-style-type: none"> • The lime treatment process is a closed sealed unit. • Inspection of the unit is not possible <p>This item has been removed from sampling program. Servicing or inspection by a qualified technician may be recommended by monitoring outcomes.</p>

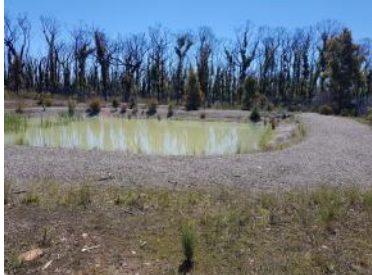
Basins	
Basin 2 (500m west)

<ul style="list-style-type: none"> • Basin is full to trickle/low flow level • Inlet and out let areas to basin are stable

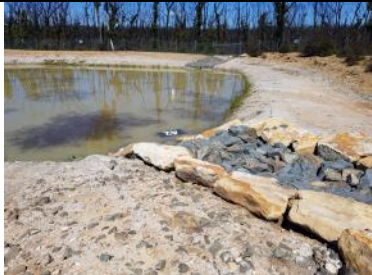
<ul style="list-style-type: none"> • Basin is full to trickle/low flow level • Significant re work has been undertaken at the main (Southern) inlet of the basin with placement of rock • Water is passing out the side of the inlet control and is leading to scour adjacent to the inlet <p>It is likely that re work of the inlet structure will be required</p>

3.	Basin 2 (500m west)	<p>Inlets and outlet areas are stable. No issues evident or required action.</p>
4.	Basin 3 (500m east)	<p>Significant re work has been undertaken at the main (Southern) inlet of the basin with placement of rock.</p> <p>Water is passing out the side of the inlet control and is leading to scour adjacent to the inlet.</p> <p>It is likely that re work of the inlet structure will be required. It is recommended that any re work include shaping of the inlet channel to create a defined inflow and is lined with geotextile.</p> <p>The rock used should consist of well graded angular material.</p>

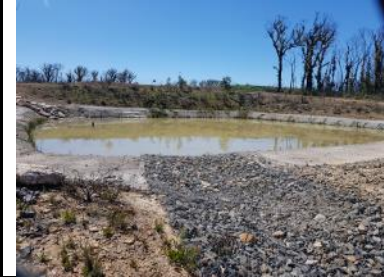
<ul style="list-style-type: none"> • The outlet control is stable

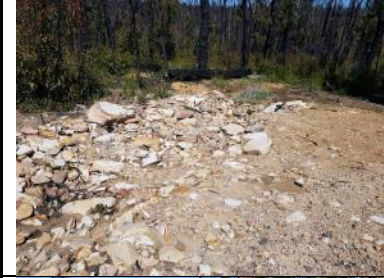
<ul style="list-style-type: none"> • The area below the outlet is stable

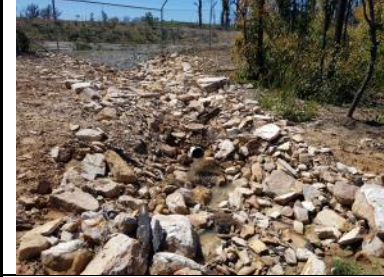
<ul style="list-style-type: none"> • Trickle/low flow outlet from Basin • Area below outlet stable – rock lined • Pipe appears to be shortened following fire damage
<p>Vegetation Health Surface Cover General comment to vegetation on 500m range</p> <ul style="list-style-type: none"> • No significant erosion evident • Significant percentage of surface cover provided by moss and lichens and weeds • In several bays drainage is an issue – this will limit plant growth in the heavy or compacted soils • Absence of real topsoil is a limitation in long term. Also very low organic matter • Further works will be required if grass cover of greater than 70% is required eg – address topsoil organic matter and issues and address drainage issues

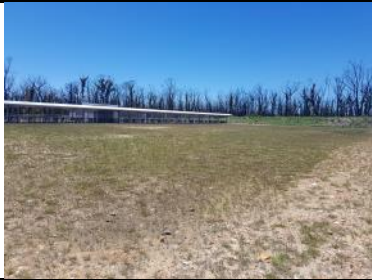
<p>Shooting Point 0m to Intermediate mound 50m</p> <ul style="list-style-type: none"> • Vegetation cover 50-70% • Nil erosion evident • Minor ponding over central area and at rear of targets

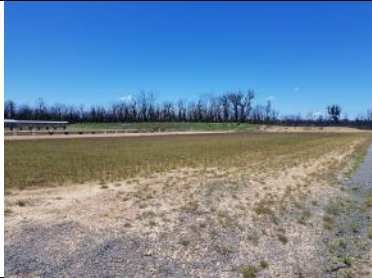
<p>Intermediate mound 50m to intermediate mound 100m</p> <ul style="list-style-type: none"> • Vegetation cover >70% • Nil erosion evident • Significant ponding over central area

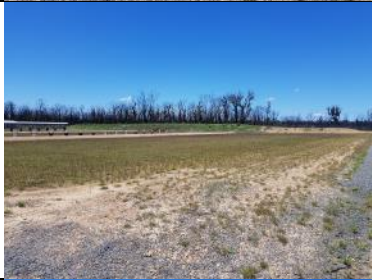
<p>Intermediate mound 100m to intermediate mound 150m</p> <ul style="list-style-type: none"> • Vegetation cover >70% • Nil erosion evident • Note that the slumping to landscape mound has been repaired and re landscaped

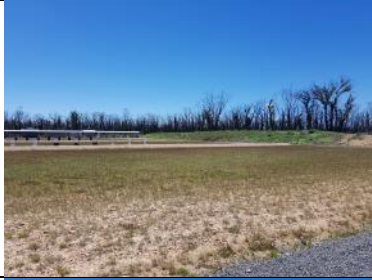
<p>Intermediate mound 150m to intermediate mound 200m</p> <ul style="list-style-type: none"> • Vegetation cover <70% • Nil erosion evident • Significant moss cover to provide surface cover

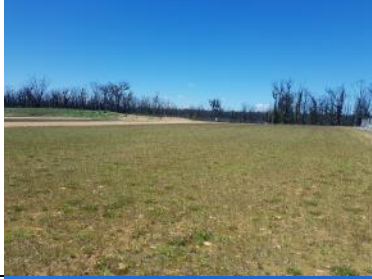
<p>Intermediate mound 200m to intermediate mound 300m</p> <ul style="list-style-type: none"> • Vegetation cover >50% • Patchy • Nil erosion evident • Poor drainage at rear of target

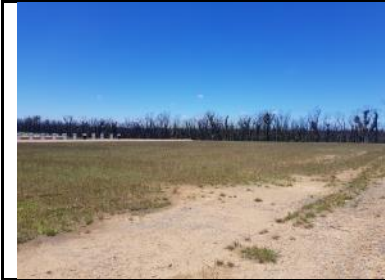
<p>Intermediate mound 385m to 500m Butt</p> <ul style="list-style-type: none"> • Vegetation cover ~30% bare with 50-70% cover over rest of surface • Nil erosion evident

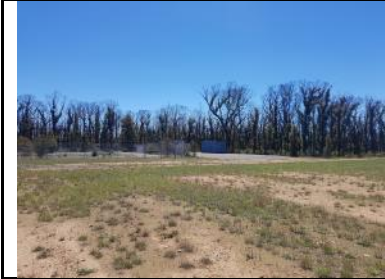
<p>New lay-down area located to north of basin2</p> <ul style="list-style-type: none"> • Gravel surface • 4 shipping containers placed to replace storage lost in fire

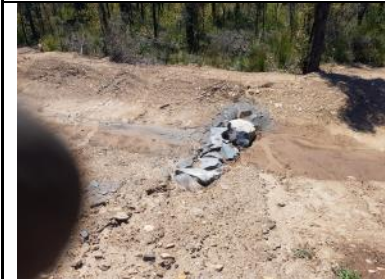
<ul style="list-style-type: none"> • Swale drain leading to south west corner of 500m stop butt • Invert of drainage swales bare with some scour/sediment loss evident • New rock check dams installed • rock size too large & no fabric installed causing water to be focused through with scour underneath <p>Recommend intermix smaller rock (75mm-150mm) into gaps of existing structures plus some smaller rock (diameter 25mm)</p>

4.	Swale drain leading to south west corner of 500m stop butt	The invert of drainage swales bare with some scour/sediment loss evident. New rock check dams have been installed. It is noted that the rock size too large with no fabric installed causing water to be focused through with scour underneath It is recommended intermix smaller rock (75mm-150mm) into gaps of existing structures plus some smaller rock (diameter 25mm). Works to revegetate the invert of the channels should be considered to reduce generation of sediment.

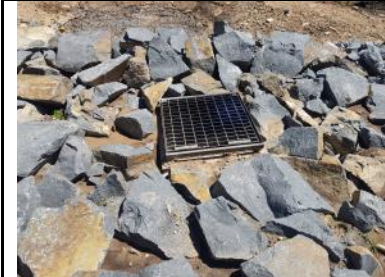
<p>Stormwater pit located at rear western corner of stop butt</p> <ul style="list-style-type: none"> • pit function reinstated following fire damage • surrounds of pit protected with rockwork

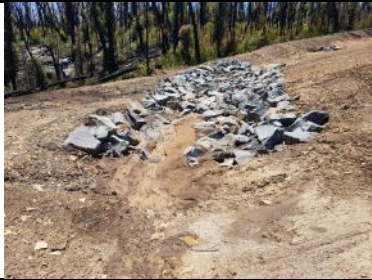
<p>Rock inlet to stormwater pit located western corner at rear of butt</p> <ul style="list-style-type: none">• Sediment from drainage swale accumulating in rock work

5.	Western corner at rear of 500m butt	Sediment from drainage swale is accumulating in rock work at the inlet to the stormwater pit. Revegetation / stabilisation works are required at the rear of the batter and invert of the swale to reduce sediment generation.

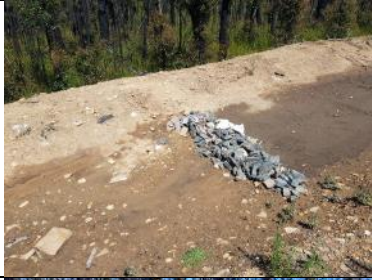
<p>Swale drains at 500m east</p> <ul style="list-style-type: none">• Installed rock checks with diameter 75-100mm• Some without fabric• Some with poor shape and outflanked on eastern side and will lead to failure

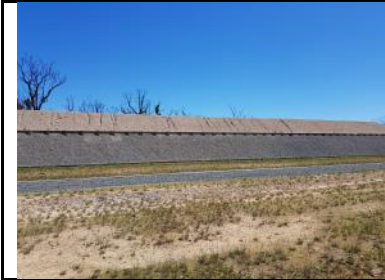
<p>Top of Stop butt at 500m</p> <ul style="list-style-type: none">• Some riling at front of batter• Occurs where water is pooling on top of butt formation and overflows over face
<p>Engineering controls: Road Infrastructure and Drainage</p>

6.	Face of stop butt at 500m	Some riling at front of batter occurring where water is pooling on top of butt formation and overflows over face. Rework of top of the mound formation will be required to prevent surface water passing over the batters of the stop butt.

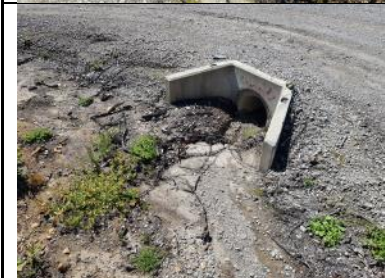
<ul style="list-style-type: none">• Some sediment deposition within table drains and at culverts

<p>Maintenance of these area should be scheduled</p>
<p>Safety and signage</p>

Item	Location	Observation and Comment
1.	50/500m	Some sediment deposition is evident within table drains and at culverts. Works in these areas to clear the sediment should be scheduled within normal maintenance program.
2.	800m	No issues or required action is evident.

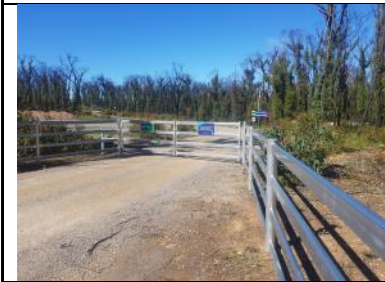
<ul style="list-style-type: none">• Safety direction signage in place

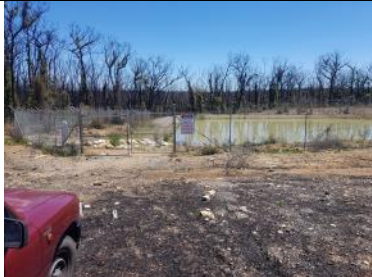
Basin 1 (at future 200m range)

<ul style="list-style-type: none"> • Surrounds to basin are stable • Basin is full to low flow outlet pipe

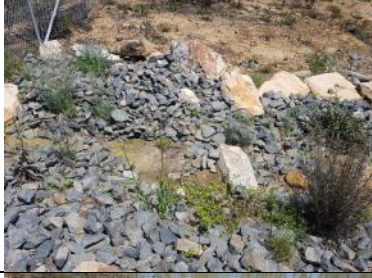
<ul style="list-style-type: none"> • Rock work at the invert has been moved by flows • Geotextile has been exposed <p>Additional works may be required in this area</p>

Item	Location	Observation and Comment
1.	Basin 1	<p>Rock work at the inlet to the basin has been moved by in-flows. Geotextile has been exposed</p> <p>Additional works may be required in this area to reinstate rock works. The rock material used should be well graded hard rock.</p>

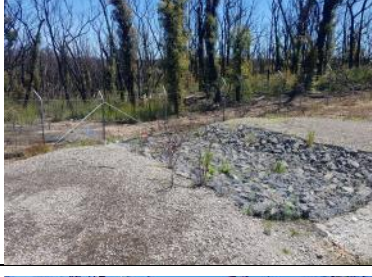
<ul style="list-style-type: none"> • Outlet control/spillway is stable

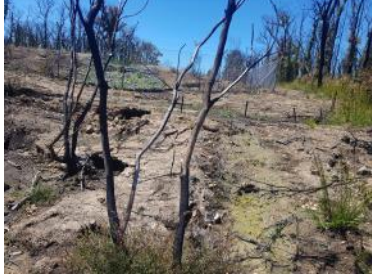
<ul style="list-style-type: none"> • "erosion" or movement of material below basin outlet evident • Loss of burnt mulch material with limited progress into underlying strata • This area to be monitored for natural regeneration following fire <p>This area may require further works and plantings, monitor for natural stabilisation and progress of erosion</p>

2.	Outlet area below Basin 1	<p>"Erosion" or movement of material below the basin outlet is evident. This loss is of burnt mulch material with limited progress into underlying soil strata.</p> <p>This area to be monitored for natural regeneration following fire.</p> <p>This area may require further works and plantings, monitor for natural stabilisation and progression of erosion.</p>

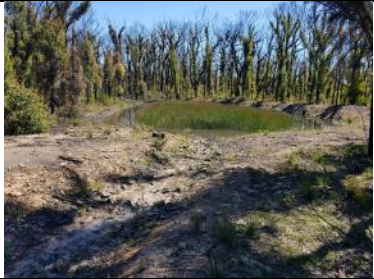
<p>Basin 4 (at car park)</p>

<ul style="list-style-type: none"> • Basin inlet and outlet stable • Basin full of reeds

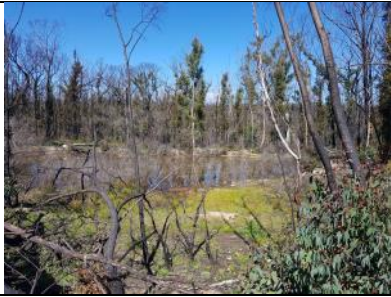
<p>Basin 7 (800m Range)</p>

<p>Basin 7/Bushland Pond</p> <ul style="list-style-type: none"> • Basin partially full of ponding water
<p>Vegetation Health</p>

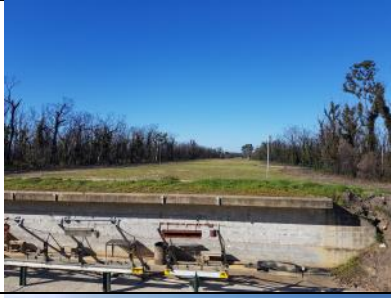
<p>Vegetative health 0-100m from target</p> <ul style="list-style-type: none"> • First 6-10m veg cover more patchy (see below) • Rest of range grass cover good

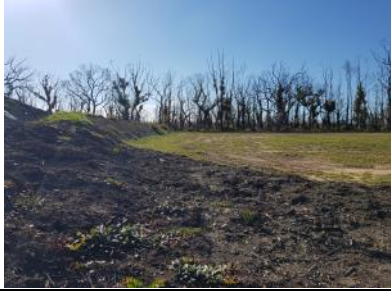
<p>Vegetative health first 6-10m from Mantlet</p> <ul style="list-style-type: none"> • 50-70% cover with patchy bare areas

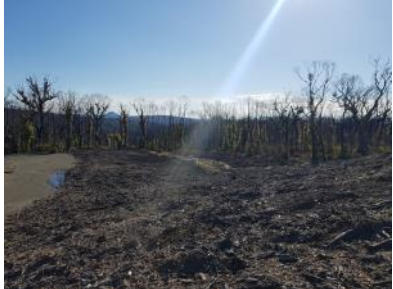
<p>Vegetative health rear of stop butt</p> <ul style="list-style-type: none"> • Vegetation establishing within channel • Mulched area still leaching water following rainfall • Organic sheen evident on surface of water
<p>Concrete Galley</p>

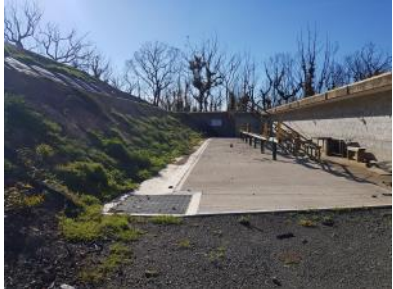
<ul style="list-style-type: none"> • Sediment, debris and blue metal (~25mm) accumulating over surface of concrete gallery
<p>Engineering controls: Road Infrastructure and Drainage</p>

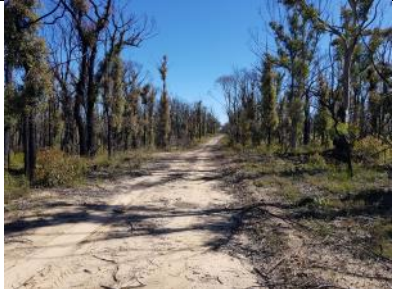
<p>Roads and Access tracks</p> <ul style="list-style-type: none"> • Range still not in use • Access track in good condition • Leaf litter and debris over surface

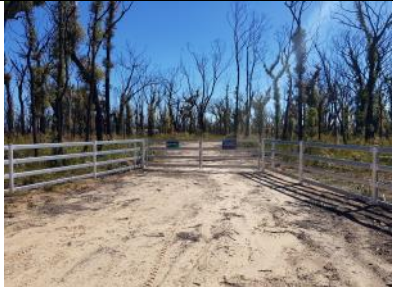
<p>Safety and signage</p> <ul style="list-style-type: none"> • New fencing and signage provided at the entrance
<p>Engineering controls: Lime treatment Process</p> <ul style="list-style-type: none"> • The lime treatment process is a closed sealed unit. • Inspection of the unit is not possible <p>This item should be removed from the sampling program. Servicing or inspection by a qualified technician may be recommended by monitoring outcomes.</p>
