# SOUTHERN HIGHLANDS REGIONAL SHOOTING COMPLEX (SHRSC)

Sampling and Analysis Quality Plan &

2020 Annual Operational Monitoring Program Report

SEPT 2020

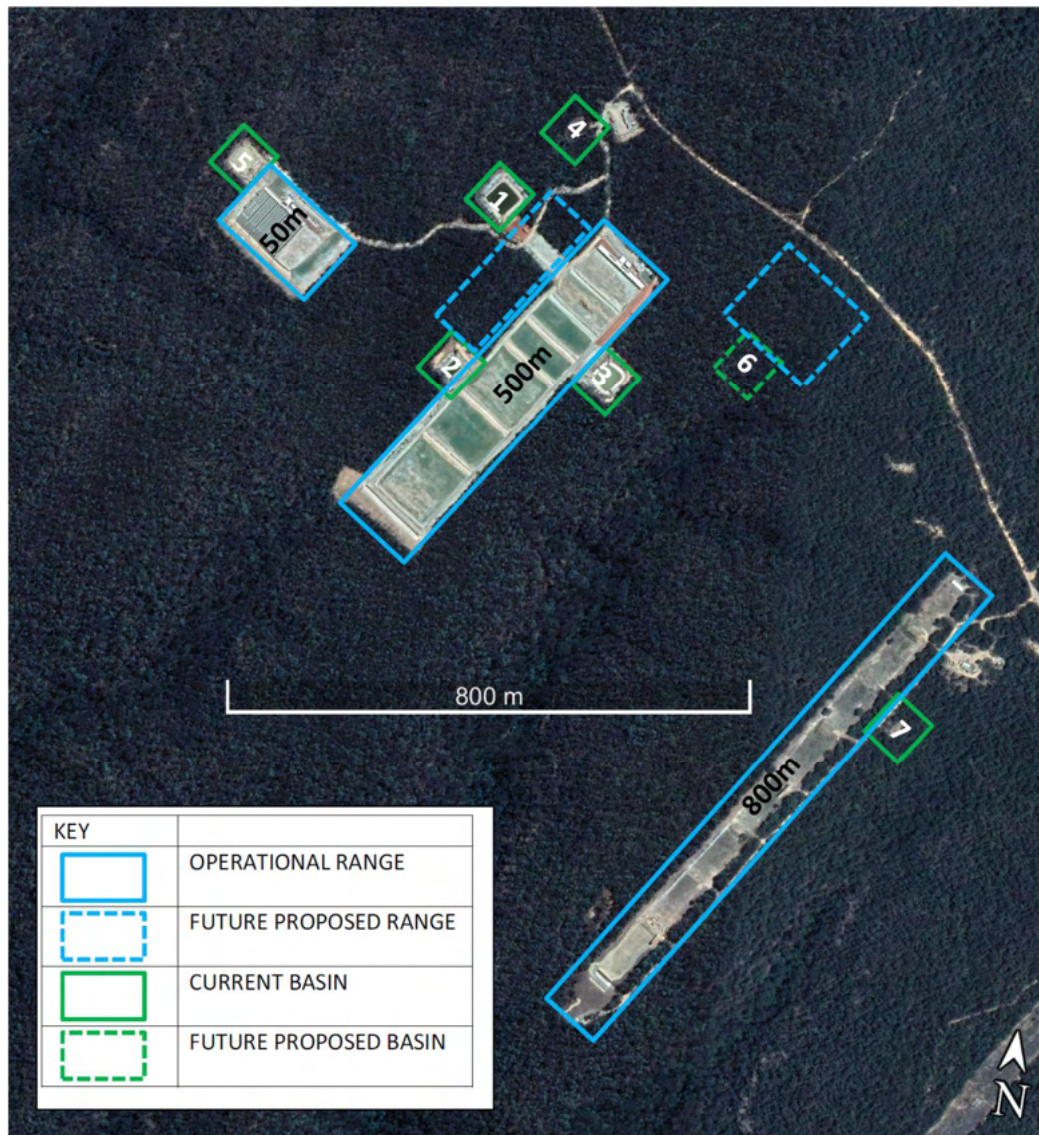
**FIGURE 3: Site Layout of the SHRSC**

**Figure 3** shows the layout at the SHRSC. Range and basin numbers are also indicated.

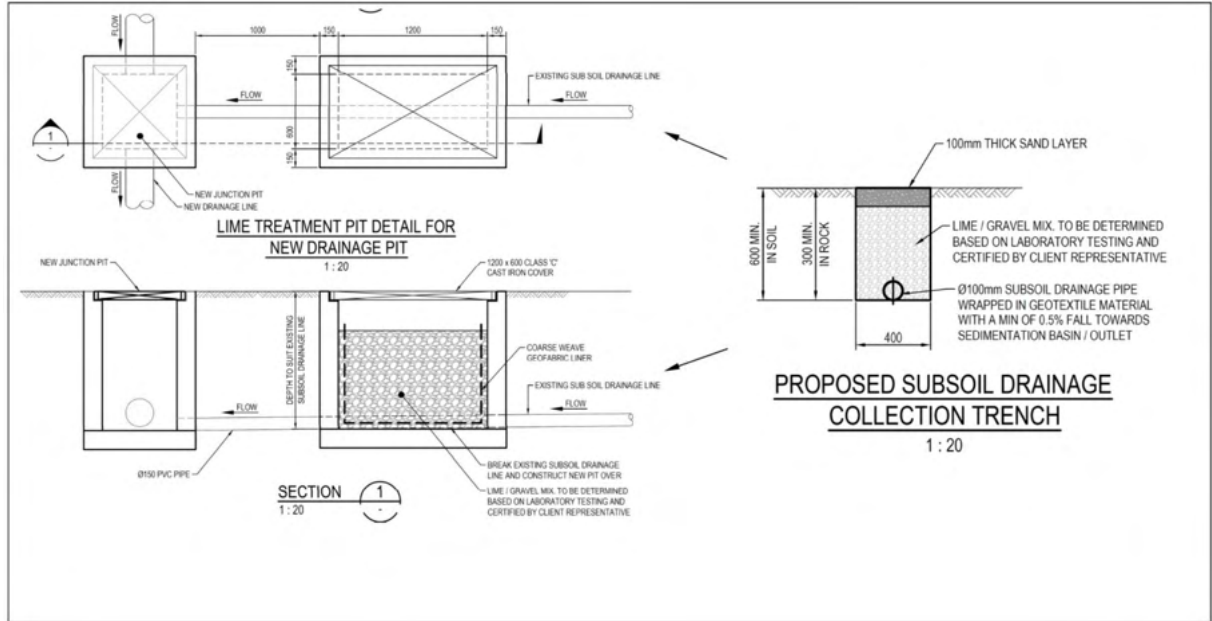
**FIGURE 4: Lime treatment and Drainage Details.**

Figure 4 provides schematic of the collection trenches and the lime treatment pits

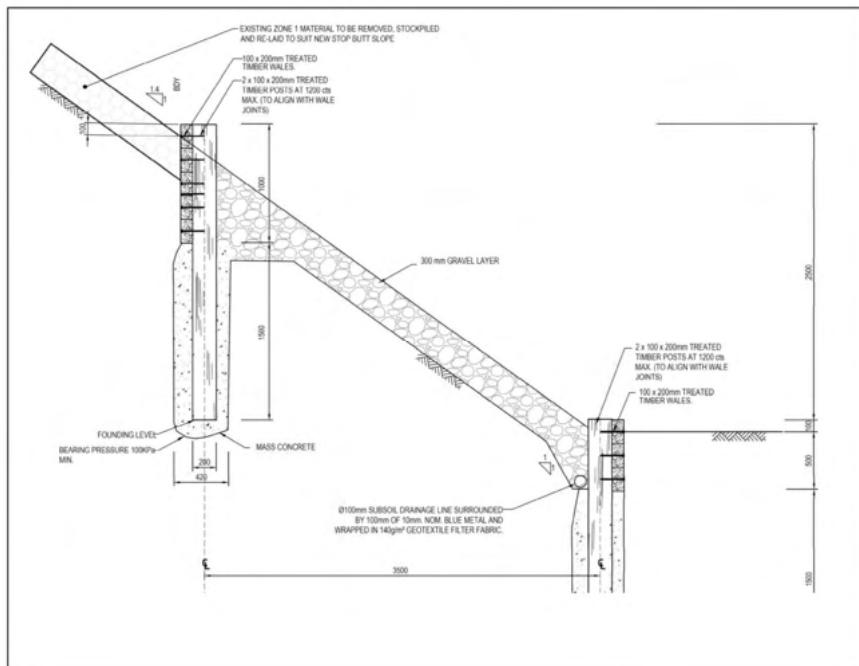
**FIGURE 5: Bullet Catcher and Stop Butt Detail.**

Figure 5 provides an indicative bullet catcher and stop butt detail.

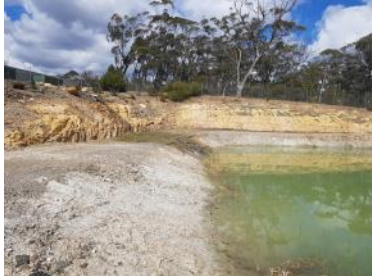
<p><b>Inlet to Basin 5</b></p> <ul style="list-style-type: none"> <li>• Scour is evident down to native rock invert at inlet to basin</li> <li>• Further scour may be unlikely</li> </ul> <p>Monitor in future inspections / sampling events</p>

Minor scour at the inlet to Basin 5 was identified within the Quarter 1. This scour is does not seem to have progressed significantly. Minor scour was observed at either side of the spillway from Basin 5. This should be monitored for change during subsequent monitoring events.

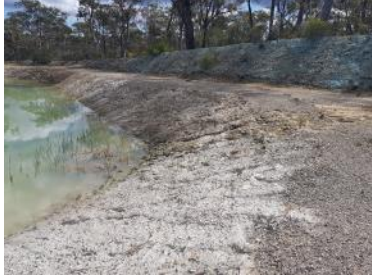
<p><b>Batters to Basin 5</b></p> <ul style="list-style-type: none"> <li>• Minor scour at batter adjacent to access ramp at gate. This should be monitored in future sampling events.</li> </ul>

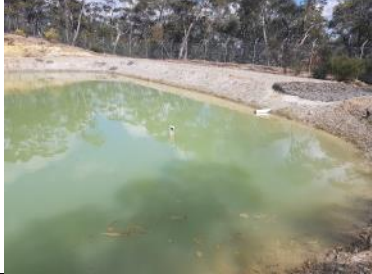
<p><b>Outlet from the Basin 5</b></p> <ul style="list-style-type: none"> <li>• Outlet from basin and spillway control are stable</li> </ul>

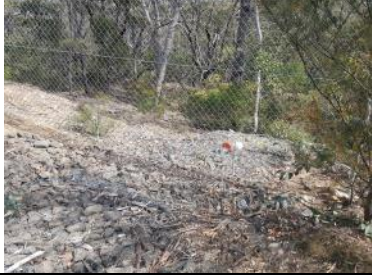
<p><b>Outlet from the Basin 5</b></p> <ul style="list-style-type: none"> <li>• Outlet from basin and spillway control are stable</li> </ul>
Vegetation Health/Surface cover

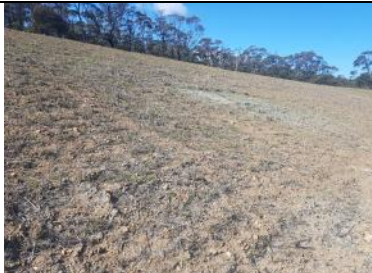
<p><b>Mound at east side of Range 1</b></p> <ul style="list-style-type: none"> <li>• Ground cover is heavily grazed</li> <li>• Vegetation cover is poor</li> <li>• Sediment loss to lower areas not evident</li> </ul>

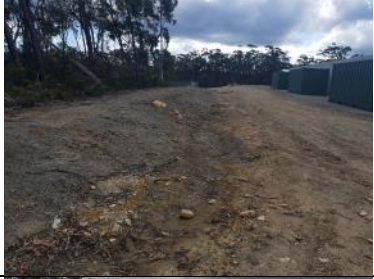
<p><b>Range floor – Range 1</b></p> <ul style="list-style-type: none"> <li>• Ground cover is heavily grazed</li> <li>• Vegetation cover is poor to nil in some areas</li> </ul>

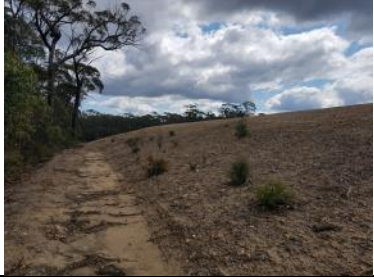
<p><b>Perimeter mound/drainage (Western side of 50m Range)</b></p> <ul style="list-style-type: none"> <li>• Vegetative Cover on mound is absent,</li> <li>• Some mulch and gravel cover</li> <li>• Surface seems generally stable</li> </ul>

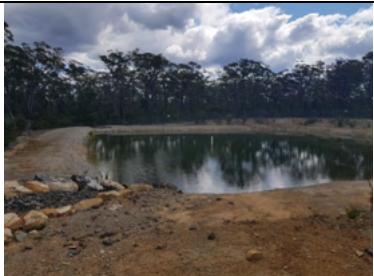
<p><b>Basin 1</b></p>

<ul style="list-style-type: none"> <li>• Batters to basin are stable.</li> <li>• Inlet and outlet measures stable</li> </ul>

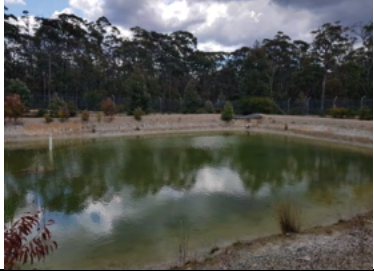
<p><b>Basin 2</b></p>

<ul style="list-style-type: none"> <li>• Inlet and Outlet controls stable</li> <li>• Batters to basins stable</li> <li>• Area below outlet is stable</li> </ul>

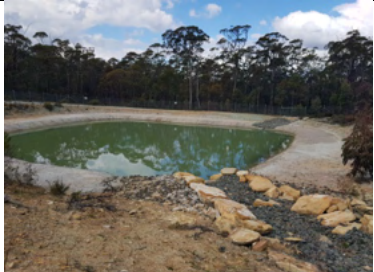
<p><b>Basin 3</b></p>

<ul style="list-style-type: none"> <li>• Scour to the side of inlet and batter adjacent Monitor this issue in subsequent inspections.</li> <li>• Outlet control from basin is stable</li> </ul>

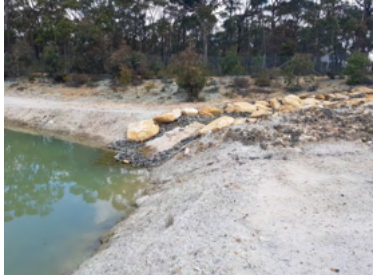
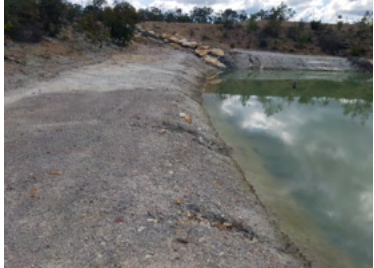
<ul style="list-style-type: none"> <li>• Minor surface erosion at localised points at batters into basin</li> </ul>

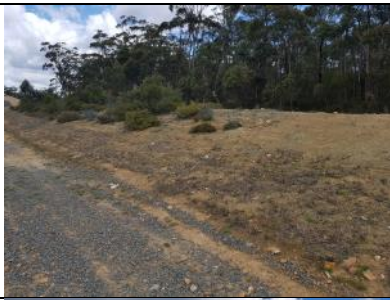
<b>Perimeter berm west side of 500m</b> <ul style="list-style-type: none"> <li>• Vegetative cover poor and patchy</li> <li>• Surface seems stable</li> <li>• Topsoil absent</li> </ul>

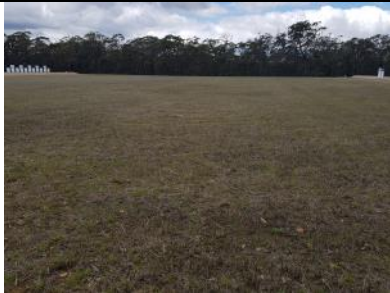
<b>Intermediate mound 385m to 500m Butt</b> <ul style="list-style-type: none"> <li>• Vegetative cover patchy with some bare areas</li> <li>• Generally 60% plus cover over surface</li> </ul>

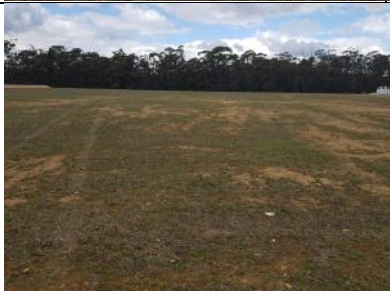
<b>Intermediate mound 300m to intermediate mound 385m</b> <ul style="list-style-type: none"> <li>• Vegetative cover good.</li> <li>• Generally 70% or more</li> </ul>

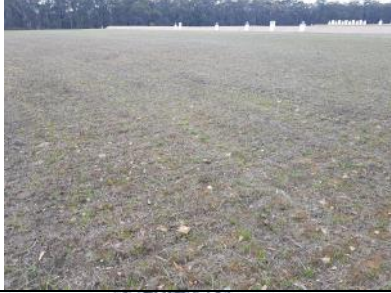
<b>Intermediate mound 200m to intermediate mound 300m</b> <ul style="list-style-type: none"> <li>• Vegetative cover very patchy or absent</li> <li>• Generally approx. 60% cover</li> </ul>

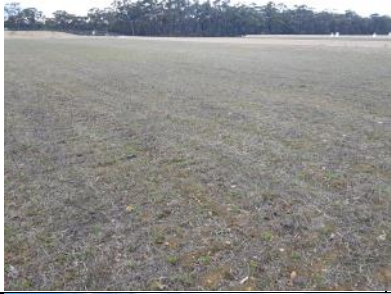
<p><b>Intermediate mound 150m to intermediate mound 200m</b></p> <ul style="list-style-type: none"> <li>• Veg cover well. generally 70% or more</li> </ul>

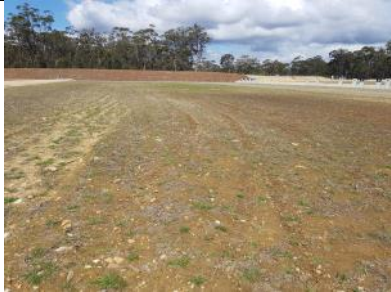
<p><b>Intermediate mound 100m to intermediate mound 150m</b></p> <ul style="list-style-type: none"> <li>• Vegetative cover good.</li> <li>• Generally 70% or more</li> </ul>

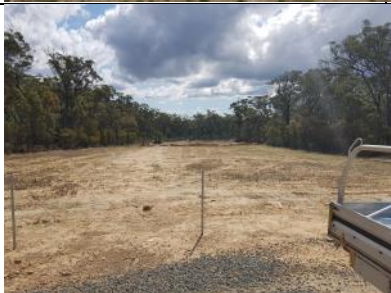
<p><b>Intermediate mound 50m to intermediate mound 100m</b></p> <ul style="list-style-type: none"> <li>• Vegetative cover very patchy</li> <li>• Generally approx. 40%</li> <li>• There is a localised wet patch in middle of range floor</li> </ul>
 	<p><b>Shooting Point 0m to Intermediate mound 50m</b></p> <ul style="list-style-type: none"> <li>• Vegetative cover very patchy or absent</li> <li>• Generally approx. 40%</li> </ul>

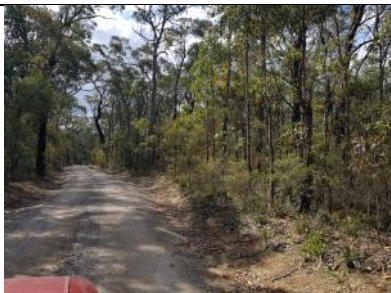
<ul style="list-style-type: none"> <li>• All road areas are stable</li> <li>• Table drains are stable</li> </ul>

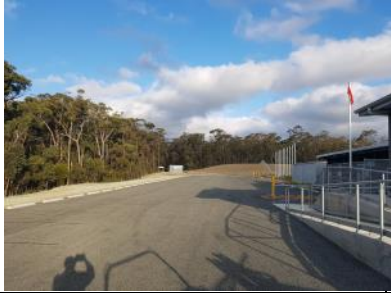
<p><b>car park area – new gravel area</b></p> <ul style="list-style-type: none"> <li>• There is evidence of hydro-mulch or tackifier applied to verges</li> <li>• Little vegetative cover evident from treatment</li> </ul>
<p><b>Safety and signage</b></p>	
 	<ul style="list-style-type: none"> <li>• Safety direction signage in place</li> </ul>

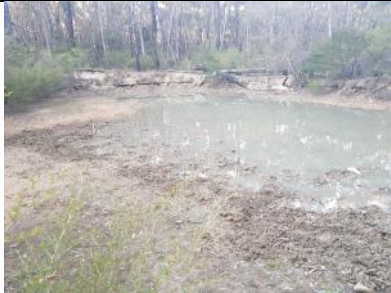
<p><b>Basin 7</b></p>

<p><b>Basin 7/Bushland Pond</b></p> <ul style="list-style-type: none"> <li>• Very low water level – evidence of animal footprints in mud</li> </ul>
<p><b>Vegetation Health</b></p>

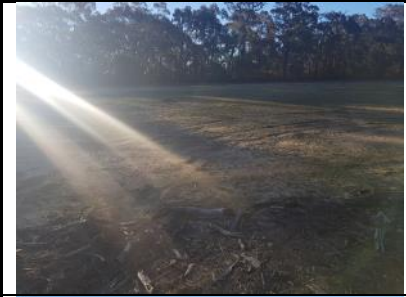
<p><b>Vegetative health 0-100m from target</b></p> <ul style="list-style-type: none"> <li>• Vegetative cover poor</li> <li>• Generally &lt; 15%</li> <li>• Surface seems stable</li> </ul>

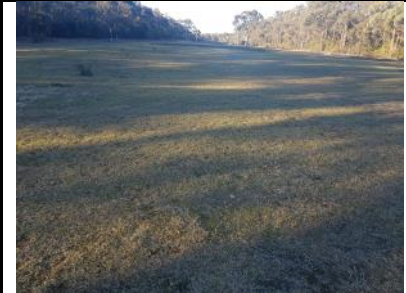
<p><b>Vegetative health 100m-800m from target</b></p> <ul style="list-style-type: none"> <li>• generally cover greater than 75% -</li> <li>• all areas heavily grazed</li> <li>• Some minor erosion on intermediate butts with evidence of burrowing from rabbits / wombats</li> </ul>
<p><b>Concrete Galley</b></p>

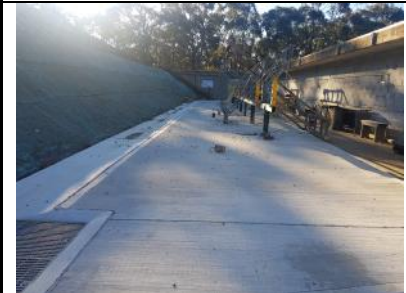
<ul style="list-style-type: none"> <li>• Surface of Galley well swept</li> <li>• Only a few fragments of bullets over the concrete</li> <li>• Note possible future issue to be addressed – fragments collecting at the side of the concrete spoon drain</li> </ul>
<p><b>Engineering controls: Road Infrastructure and Drainage</b></p>	
 	<p><b>Roads and Access tracks</b></p> <ul style="list-style-type: none"> <li>• All surfaces in good condition</li> </ul>

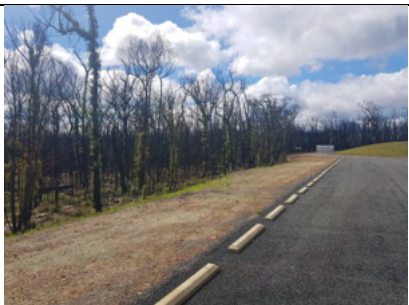
<ul style="list-style-type: none"> <li>• Bushland adjacent to range severely burnt</li> <li>• Epicormic growth evident over standing trees and from basal areas of trees</li> <li>• Limited to no regeneration of lower story vegetation</li> </ul>

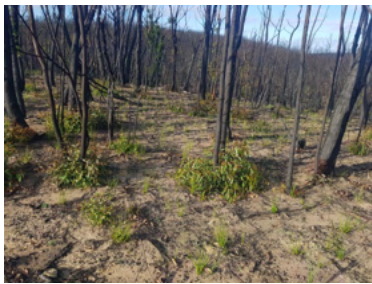
<ul style="list-style-type: none"> <li>• Bushland area was severely impacted by Bushfires (December 2019-Feb 2020)</li> <li>• No leaf litter evident</li> <li>• Some epicormic growth at base and along stems (limited) post fire</li> <li>• Some germination evident of ground covers post fire</li> <li>• Soil desiccated with upper profile heaved and structure-less (feeling spongy under foot ) due to organic matter being burned to depth and subsoil burned</li> </ul>
---	---

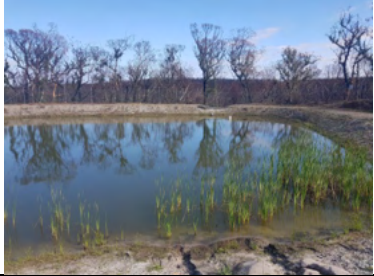
<ul style="list-style-type: none"> <li>• WQ within 50m basin visually clear</li> <li>• Full to overflow level</li> </ul>

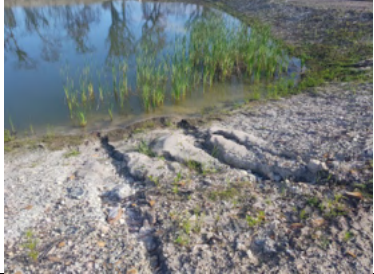
<ul style="list-style-type: none"> <li>• Minor scour at gate from surface flow drainage –</li> </ul> <p>Monitor for stability over time</p>

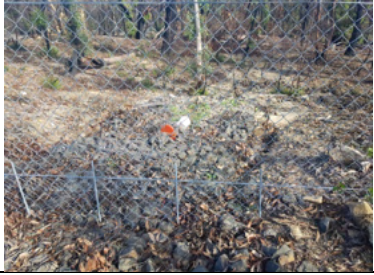
<ul style="list-style-type: none"> <li>• Minor scour at either side of gabion spillway –</li> <li>• Monitor for stability over time</li> </ul>
<p><b>Vegetation Health/Surface cover</b></p>	
<p><b>Vegetation health</b></p> <ul style="list-style-type: none"> <li>• See comments RANGE 1 below</li> <li>• Other RANGES (2-5) are gravel surface with no vegetation</li> </ul>

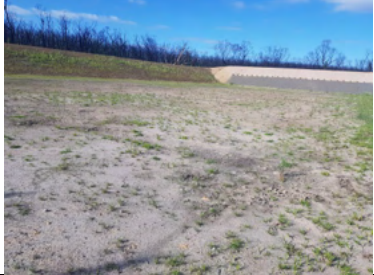
<p><b>Range floor – Range 1</b></p> <ul style="list-style-type: none"> <li>• Vegetative cover very poor</li> <li>• &lt; 10% - associated with poor drainage and ponding in central area</li> <li>• Note observations of flooded range 6<sup>th</sup> March 2020</li> </ul> <p>Monitor this area for ongoing stability in future inspections to confirm if vegetation cover improves.</p>

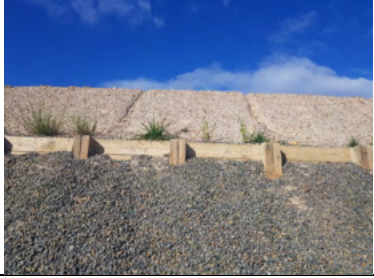
<ul style="list-style-type: none"> <li>• Minor and localised Erosion on butts above bullet catcher</li> <li>• This is associated with the shape of the butt and existence of the flat top of the butt</li> </ul> <p>Resolution could be achieved by shaping the top of the butt with a small in-fall to create a swale leading to defined outlet points(s) with scour protection or grading to one side so water sheets off</p>
<p><b>Engineering controls: Lime treatment Process</b></p> <ul style="list-style-type: none"> <li>• The lime treatment process is a closed sealed unit.</li> <li>• Inspection of the unit is not possible</li> </ul> <p>This item should be removed from the sampling program. Servicing or inspection by a qualified technician may be recommended by monitoring outcomes.</p>	
<p><b>Engineering controls: Road Infrastructure and Drainage</b></p> <ul style="list-style-type: none"> <li>• Road Infrastructure and Drainage for the 50m range is addressed within Section 11.3.2</li> </ul>

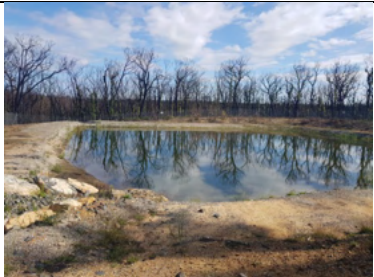
<p><b>Basin 1</b></p>

<ul style="list-style-type: none"> <li>• Basin almost full</li> <li>• Water very clear</li> </ul>

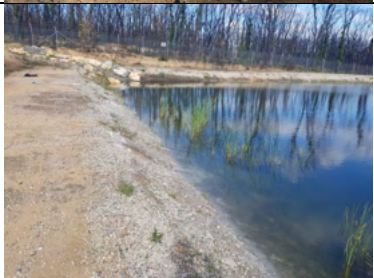
<ul style="list-style-type: none"> <li>• Minor scour at batters to basin</li> </ul>

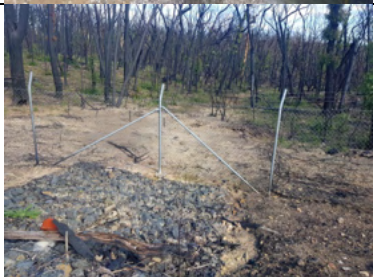
<ul style="list-style-type: none"> <li>• Minor scour at northern side of spillway</li> <li>• May be due to debris on spillway</li> <li>• Monitor for progress over time</li> </ul>

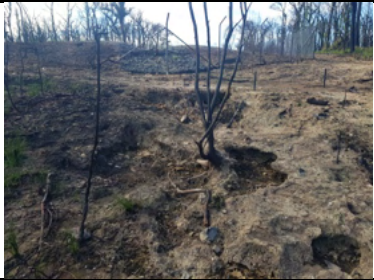
<ul style="list-style-type: none"> <li>• Significant scour below spillway area but seems to be within accumulated sediment with ex mulched material and not significantly into natural material</li> </ul> <p><u>Monitor for progress over time</u></p>
<p><b>Basin 2</b></p>

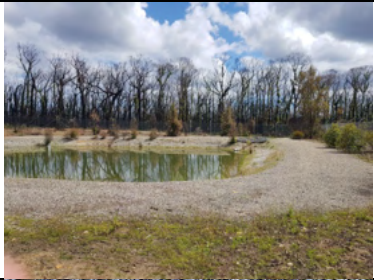
<ul style="list-style-type: none"> <li>• Water very clear</li> <li>• Outlet area and perimeter stable</li> </ul>

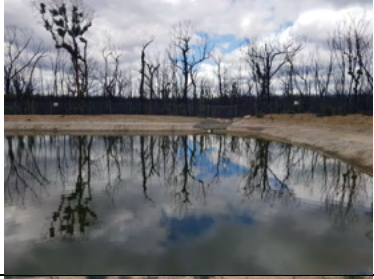
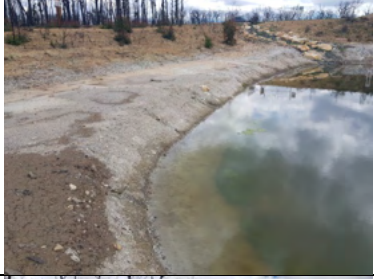
<ul style="list-style-type: none"> <li>• Water very clear</li> <li>• Scour in multiple locations at perimeter access track where drainage focuses flow to low points leading to scour Inlet area failing – monitor for change</li> </ul>

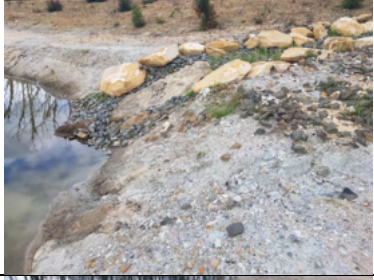
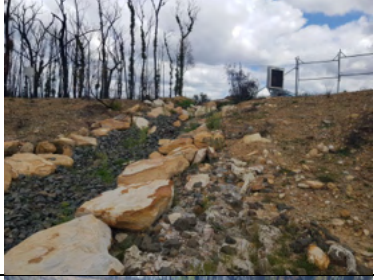
<ul style="list-style-type: none"> <li>• Scour at inlet where rock material failed and moved</li> </ul>

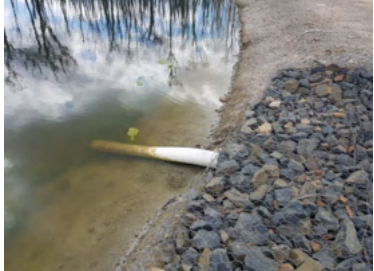
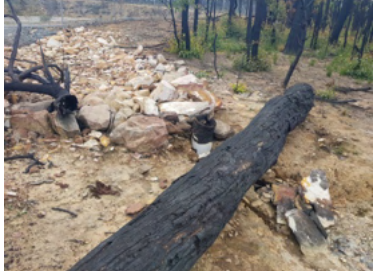
<ul style="list-style-type: none"> <li>• Outlet pipe/low flow melted in two locations</li> <li>• Scour below</li> </ul>

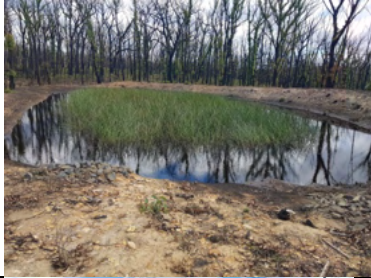
<ul style="list-style-type: none"> <li>• Batters and outlet stable</li> <li>• Water black with tannins</li> <li>• Likely derived from mulch stockpile located upstream in car park area</li> <li>• Monitor for tannin staining in future inspections</li> </ul>

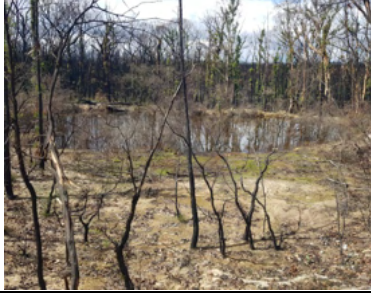
<p><b>Basin 7</b></p>

<ul style="list-style-type: none"> <li>• Water within side pond/basin clear</li> <li>• Bushland burnt surrounding</li> <li>• Tadpoles observed in basin</li> </ul>
<p><b>Vegetation Health Surface Cover</b></p>

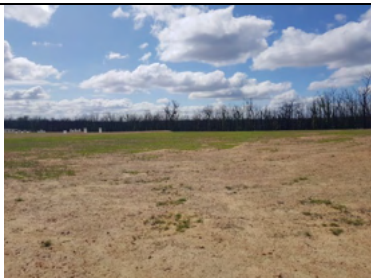
<p><b>Intermediate mound 385m to Butt 500m</b></p> <ul style="list-style-type: none"> <li>• Vegetative cover patchy to absent over ~30% of area</li> <li>• Where present, vegetation cover over 70% cover</li> <li>• Surface stable</li> </ul>

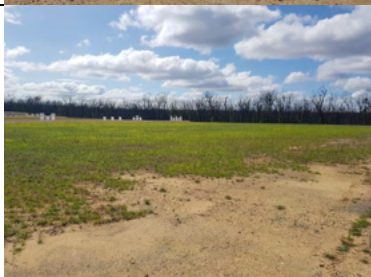
<p><b>Intermediate mound 300m to intermediate mound 385m</b></p> <ul style="list-style-type: none"> <li>• Good cover over 70% + over 100% of area including moss cover</li> <li>• Surface stable</li> </ul>

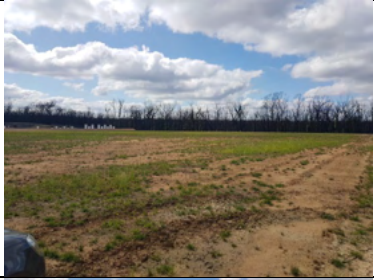
<p><b>Intermediate mound 200m to intermediate mound 300m</b></p> <ul style="list-style-type: none"> <li>• Vegetative cover patchy to absent over ~50% of area</li> <li>• Where present vegetation cover over is 70%</li> <li>• Surface stable</li> </ul>

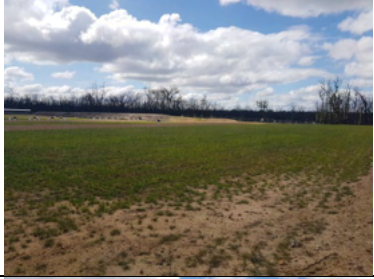
<p><b>Intermediate mound 150m to intermediate mound 200m</b></p> <ul style="list-style-type: none"> <li>• Good cover over 100% of area with ~50%-70%+</li> <li>• Surface stable</li> </ul>

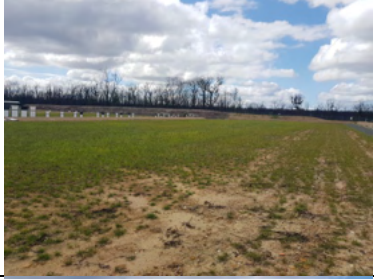
<p><b>Intermediate mound 100m to intermediate mound 150m</b></p> <ul style="list-style-type: none"> <li>• Good cover over 100% of area with ~70%+</li> <li>• Surface stable</li> </ul>

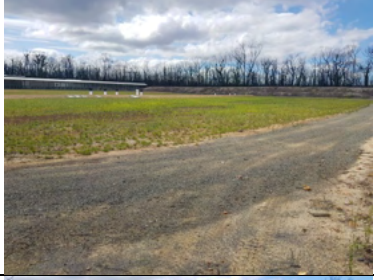
<p><b>Intermediate mound 50m to intermediate mound 100m</b></p> <ul style="list-style-type: none"> <li>• Good cover over 100% of area with ~70%+ except in central area where water ponds</li> <li>• Surface stable</li> </ul>

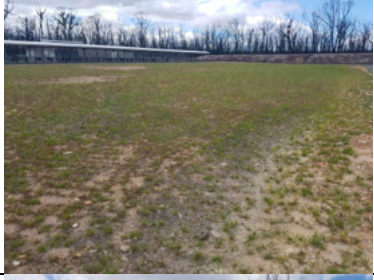
<p><b>Shooting Point 0m to intermediate mound 550m</b></p> <ul style="list-style-type: none"> <li>• Patchy cover with 50% of area bare</li> <li>• Cover ~50% where present</li> <li>• Surface stable</li> </ul>

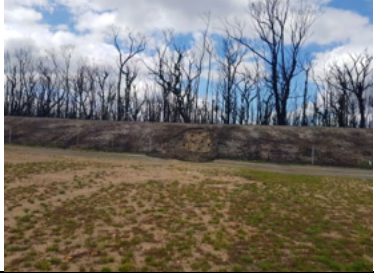
<ul style="list-style-type: none"> <li>• Slump in Eastern landscape bund where landscape has failed</li> </ul>
<p><b>Engineering Controls – Drainage</b></p>

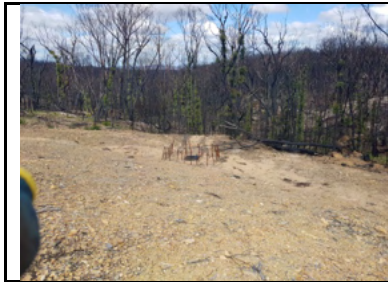
Drainage (South west corner)

- Swales leading to South West are bare with vegetative cover burnt
- Drainage controls burnt out Pipe outlet from stormwater pit melted internally

To be repaired

The stormwater pit and pipe outlet at the south western corner of the 500m range (behind the 500m stop butt) has been severely impacted by the fires with the PVC pipe melted within the pit. This will need to be replaced.

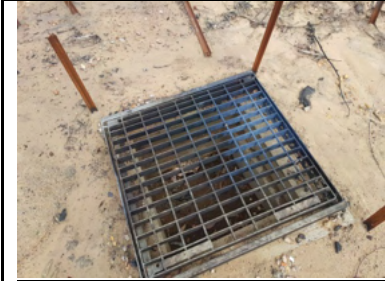
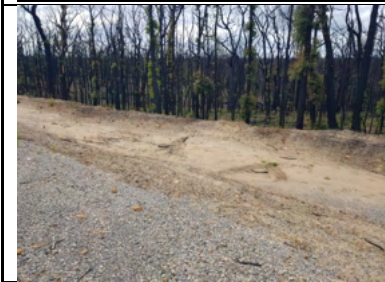
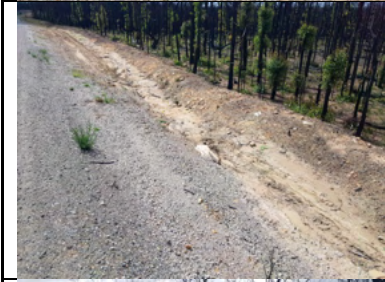
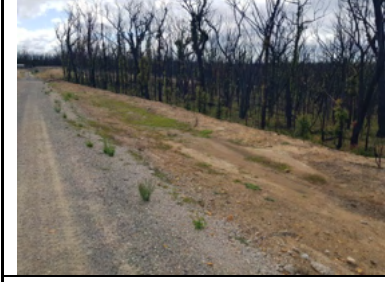
500m Drainage (eastern side)

- Swales: cover burnt
- Significant sediment movement and scour

The swale may require maintenance and erosion control to prevent the swales failing to the bushland to east

Sediment has accumulated within the swale drain on the eastern side of the 500m range. This swale may require maintenance with provision of additional erosion control if a vegetative cover does not re-establish. It is recommended that this is monitored in subsequent visual inspections and maintenance be scheduled if/when required.

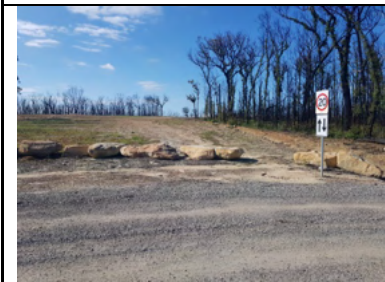
- Track surfaces stable and well drained across all areas – no issues

<ul style="list-style-type: none"> <li>• Significant sediment accumulation in table drains and other drainage derived from adjacent bushland. This sediment loss is likely exacerbated post the fires</li> <li>• This may impact on function of swales and table drains over time and is expected to progress further over intermediate period due to loss of vegetative and mulch cover during fires</li> </ul>
 	<p>Recommend that this is Monitored over time with scheduled maintenance when required</p>
<p><b>Safety and signage</b></p>	
 	<p><b>50/500m</b></p> <ul style="list-style-type: none"> <li>• Basin safety signage in place</li> <li>• General road signage in place however some damaged</li> </ul>
<p><b>Range perimeter for shot loss – ALL RANGES.</b></p> <ul style="list-style-type: none"> <li>• No shot loss evident – Note this is difficult /impossible to ascertain due to bushfire impact</li> </ul>

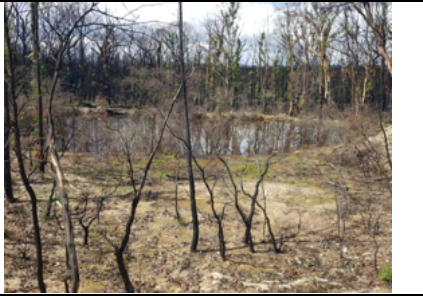
<p><b>Basin 7</b></p>

<ul style="list-style-type: none"> <li>• Water within side pond/basin clear</li> <li>• Bushland burnt surrounding</li> <li>• Tadpoles observed in basin</li> </ul>
<p><b>Vegetation Health</b></p>

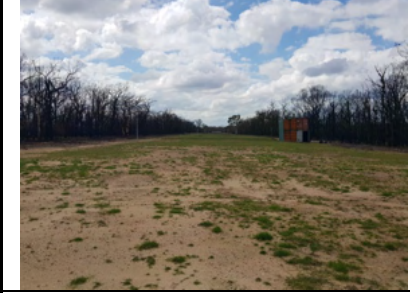
<ul style="list-style-type: none"> <li>• Surface cover patchy per previous inspections especially in the first 50-100m</li> <li>• Heavily grazed</li> <li>• Surface stable</li> </ul>
<p><b>Engineering Controls</b></p>

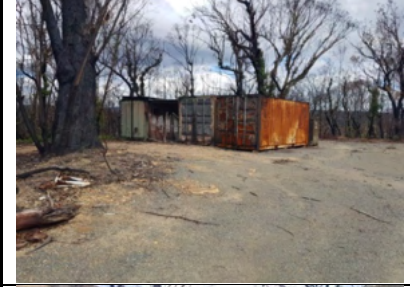
<p><b>Shipping containers rear of Stop Butt</b></p> <ul style="list-style-type: none"> <li>• Significant damage to infrastructure during fires</li> </ul>

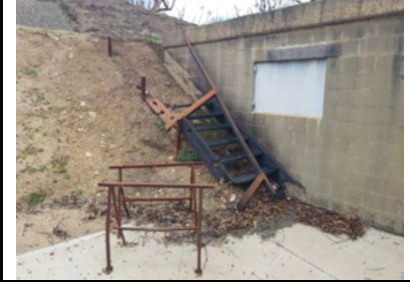
<p><b>Concrete Galley</b></p> <ul style="list-style-type: none"> <li>• Significant damage to infrastructure during fires</li> </ul>

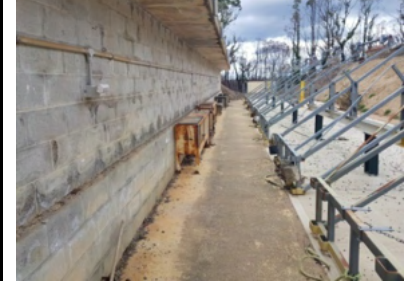
<p><b>Concrete Galley</b></p> <ul style="list-style-type: none"> <li>• Limited gravel and sediment accumulated within the gallery</li> <li>• Plus other debris post fire (limited)</li> </ul>

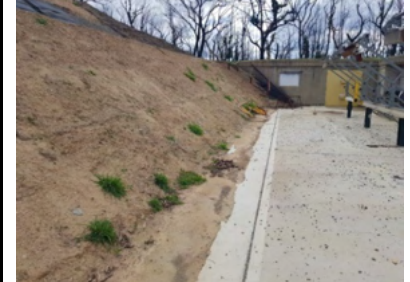
<p><b>Concrete Galley</b></p> <ul style="list-style-type: none"> <li>• Significant sediment loss from batter on south side of gallery</li> <li>• Following loss of stabilising surface</li> <li>• Sediment to be sampled</li> <li>• Monitor area and include stabilisation in rectification works</li> </ul>

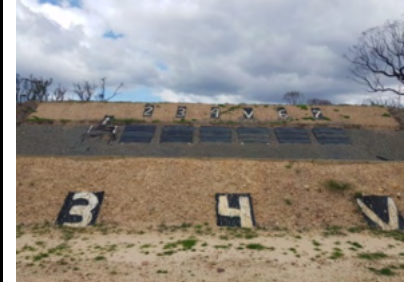
<p><b>Stop butt &amp; Bullet Catchers</b></p> <ul style="list-style-type: none"> <li>• Bullet catchers covered with conveyor belting</li> <li>• Limits collection of samples per SAQP</li> <li>• Bullet catcher 1 – belting and bullet catcher surround burnt – sample taken from this area only</li> </ul>

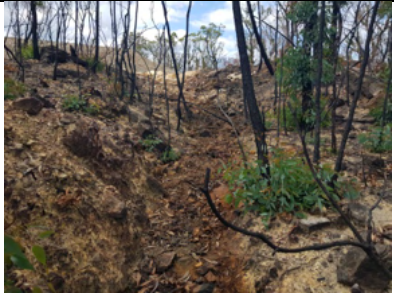
<ul style="list-style-type: none"> <li>• Areas below culvert outlets stable</li> </ul>

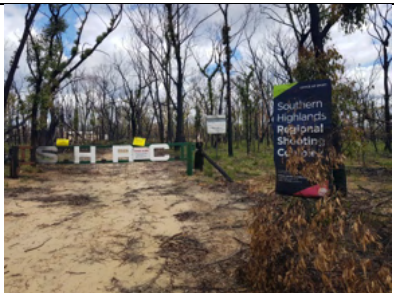
<ul style="list-style-type: none"> <li>• Access tracks surface and drainage stable</li> <li>• Significant debris remaining over surface of tracks</li> </ul>
<b>Safety and signage</b>
