Part B: Monitoring Program Implementation and Report

9 Monitoring Program – Quarter 1

Summary of sampling event

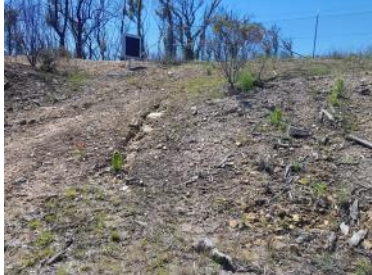
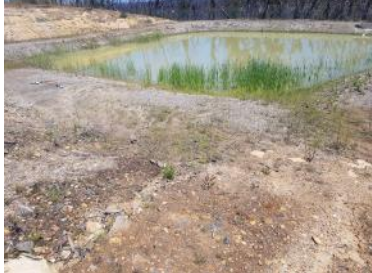
<ul style="list-style-type: none"> • Scour over batter at entrance to basin enclosure • Water directed by surface water swale to entrance track to basin • Scour leads down access track to spread at bench and then down batter at basin <p>Suggest a formalise drain will be required in this location to arrest further scour – rock over fabric</p>

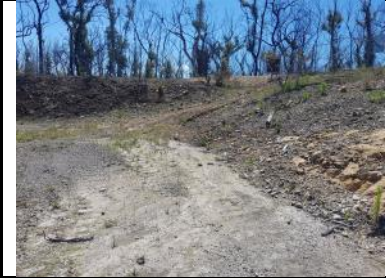
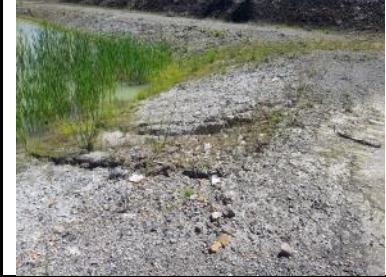
<ul style="list-style-type: none"> • Water flowing from water treatment process / pits exiting low flow pipe to basin

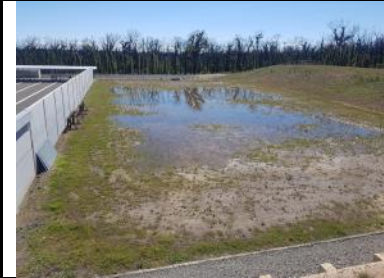
<p>Range/Bay 1</p> <ul style="list-style-type: none"> • Water pooling in central area • Not riling over batter of butt to South western side

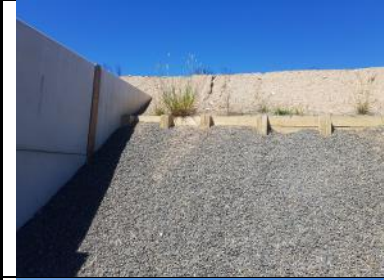
<p>Mound SE of Range/Bay1</p> <ul style="list-style-type: none"> • Vegetation patchy – surface generally stable • Some sediment localised loss

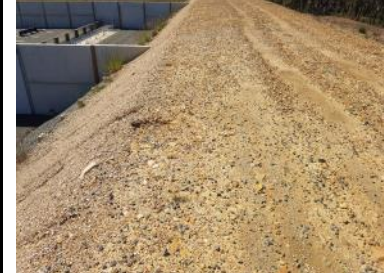
<p>Top of Stop butt at 500m</p> <ul style="list-style-type: none"> • Some riling at front of batter • Occurs where water is pooling on top of butt formation and overflows over face <p>Rework of top of the mound formation will be required to prevent surface water passing over the batters of the stop butt.</p>

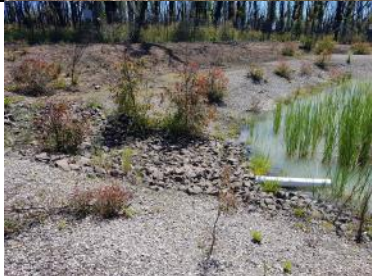
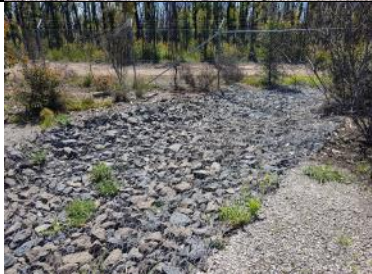
<ul style="list-style-type: none"> • Basin is full to trickle/low flow level • Inlet and out let areas to basin are stable

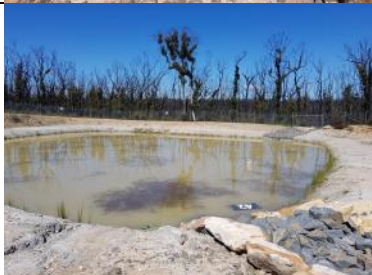
<ul style="list-style-type: none"> • Basin is full to trickle/low flow level • Significant re work has been undertaken at the main (Southern) inlet of the basin with placement of rock • Water is passing out the side of the inlet control and is leading to scour adjacent to the inlet <p>It is likely that re work of the inlet structure will be required</p>

3.	Basin 2 (500m west)	<p>Inlets and outlet areas are stable. No issues evident or required action.</p>
4.	Basin 3 (500m east)	<p>Significant re work has been undertaken at the main (Southern) inlet of the basin with placement of rock.</p> <p>Water is passing out the side of the inlet control and is leading to scour adjacent to the inlet.</p> <p>It is likely that re work of the inlet structure will be required. It is recommended that any re work include shaping of the inlet channel to create a defined inflow and is lined with geotextile.</p> <p>The rock used should consist of well graded angular material.</p>

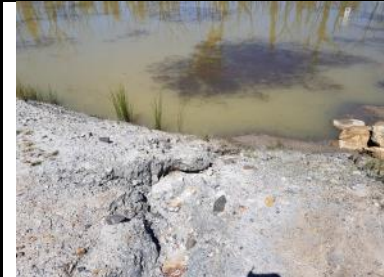
<ul style="list-style-type: none"> • The outlet control is stable

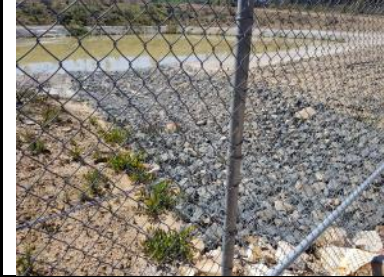
<ul style="list-style-type: none"> • The area below the outlet is stable

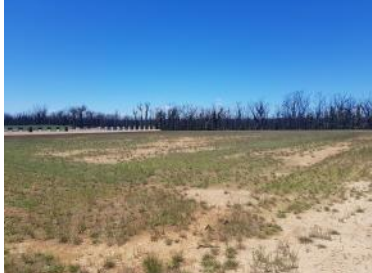
<p>Intermediate mound 200m to intermediate mound 300m</p> <ul style="list-style-type: none"> • Vegetation cover >50% • Patchy • Nil erosion evident • Poor drainage at rear of target

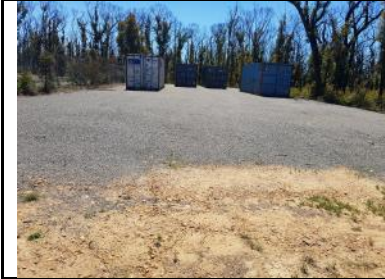
<p>New lay-down area located to north of basin2</p> <ul style="list-style-type: none"> • Gravel surface • 4 shipping containers placed to replace storage lost in fire

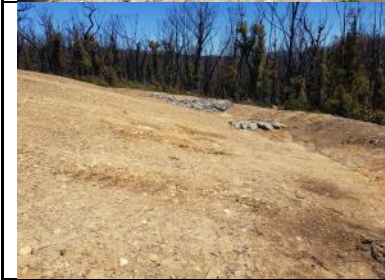
<ul style="list-style-type: none"> • Swale drain leading to south west corner of 500m stop butt • Invert of drainage swales bare with some scour/sediment loss evident • New rock check dams installed • rock size too large & no fabric installed causing water to be focused through with scour underneath <p>Recommend intermix smaller rock (75mm-150mm) into gaps of existing structures plus some smaller rock (diameter 25mm)</p>

4.	Swale drain leading to south west corner of 500m stop butt	The invert of drainage swales bare with some scour/sediment loss evident. New rock check dams have been installed. It is noted that the rock size too large with no fabric installed causing water to be focused through with scour underneath It is recommended intermix smaller rock (75mm-150mm) into gaps of existing structures plus some smaller rock (diameter 25mm). Works to revegetate the invert of the channels should be considered to reduce generation of sediment.

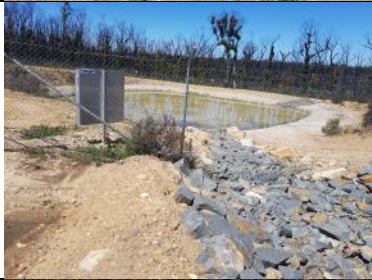
<p>New rock work at inlet to Basin 3 (500m East)</p>

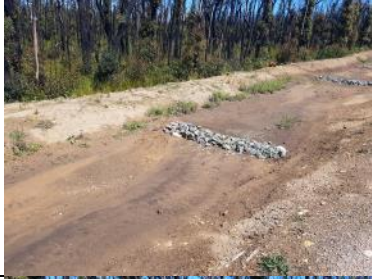
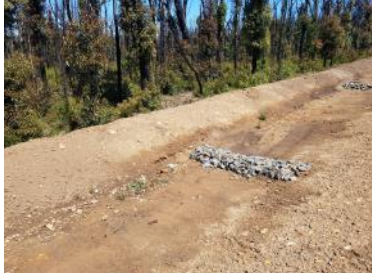
<p>Swale drains at 500m east</p> <ul style="list-style-type: none">• Installed rock checks with diameter 75-100mm• Some without fabric• Some with poor shape and outflanked on eastern side and will lead to failure

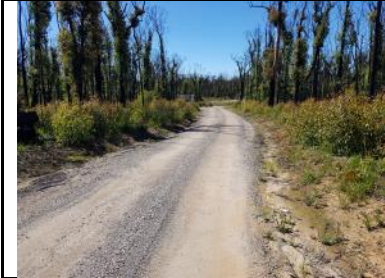
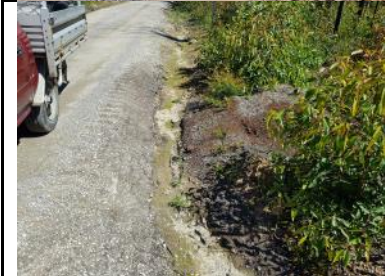
<p>Top of Stop butt at 500m</p> <ul style="list-style-type: none">• Some riling at front of batter• Occurs where water is pooling on top of butt formation and overflows over face
<p>Engineering controls: Road Infrastructure and Drainage</p>

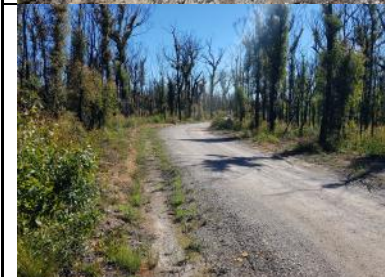
<ul style="list-style-type: none">• Some sediment deposition within table drains and at culverts

<p>Maintenance of these area should be scheduled</p>
<p>Safety and signage</p>

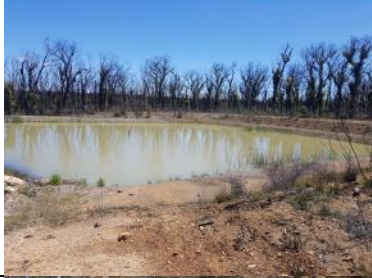
<ul style="list-style-type: none"> • Surrounds to basin are stable • Basin is full to low flow outlet pipe

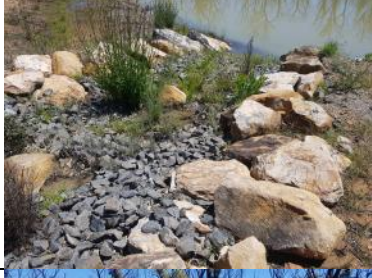
<ul style="list-style-type: none"> • Rock work at the invert has been moved by flows • Geotextile has been exposed <p>Additional works may be required in this area</p>
